Project Name: The Outlook Stage 6
Project Number: IH001601

Subject: Stability Assessment As-Constructed Batters

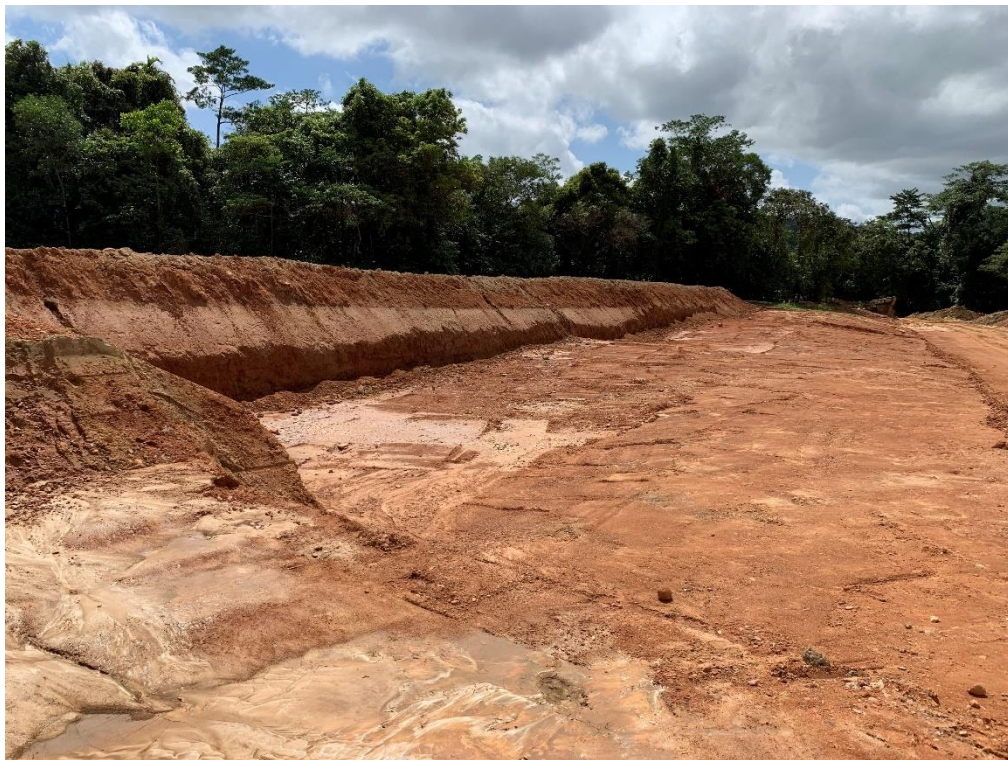
Figure 2: Batter in Lots 615, 616, 618 and 619 on 23 September 2020

An initial visit was carried out on 23 September 2020. At this stage the construction of the batter on Lots 615, 616, 618 and 619 and Lots 601 to 607 were under construction. Two DCP tests were carried out (see Appendix B). A small weaker area was observed on the cut and fill slope at Lot 618, however it must be noted that the slope was yet to be trimmed back to its final batter.

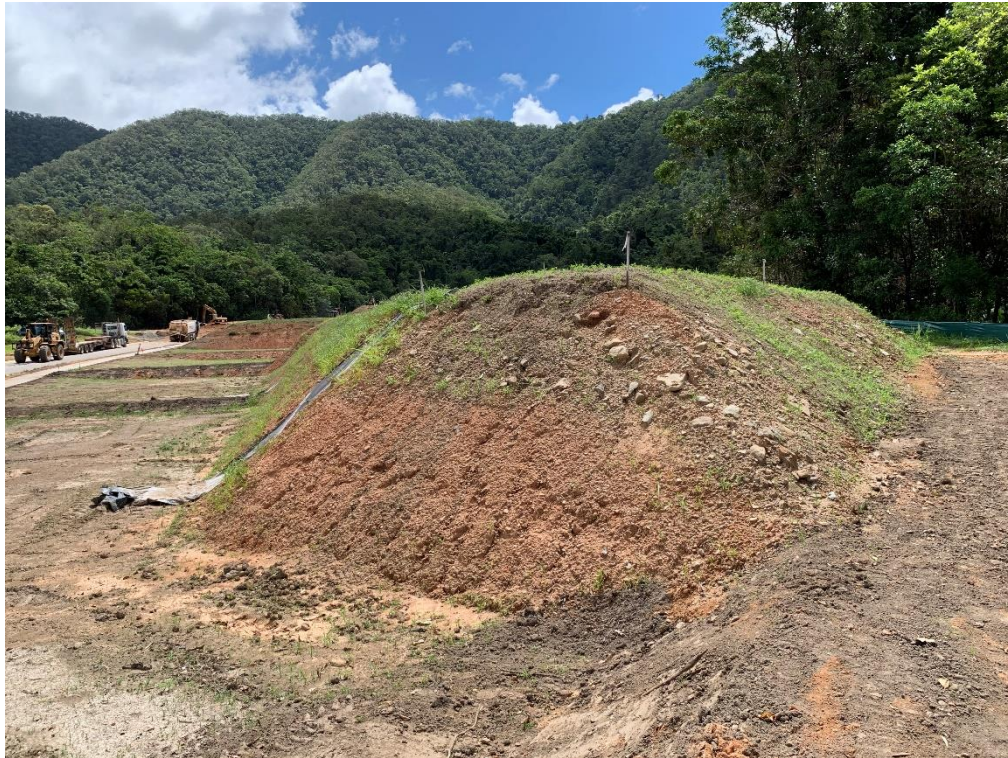
Figure 3: Batter in Lots 615, 616, 618 and 619 on 15 March 2021

- Lots 615, 616, 618 and 619:
 - Design: 1V:1H batter slope, up to 3m high;
 - As constructed: up to 45 degrees batter slope, up to 3.4m high, in the 90 degrees corner in Lot 615 batter locally up to 48.5 degrees, very stiff to hard fill and residual soil; and
 - Additional observations: Weak layer previously observed not observed anymore.

- The following design load set-back from the batter crest is adopted:
 - Lots 609 to 616, 618 and 619 – minimum 3m.
- A maximum slope batter of 1V:1H is maintained for all specified 1V:1H design batters.

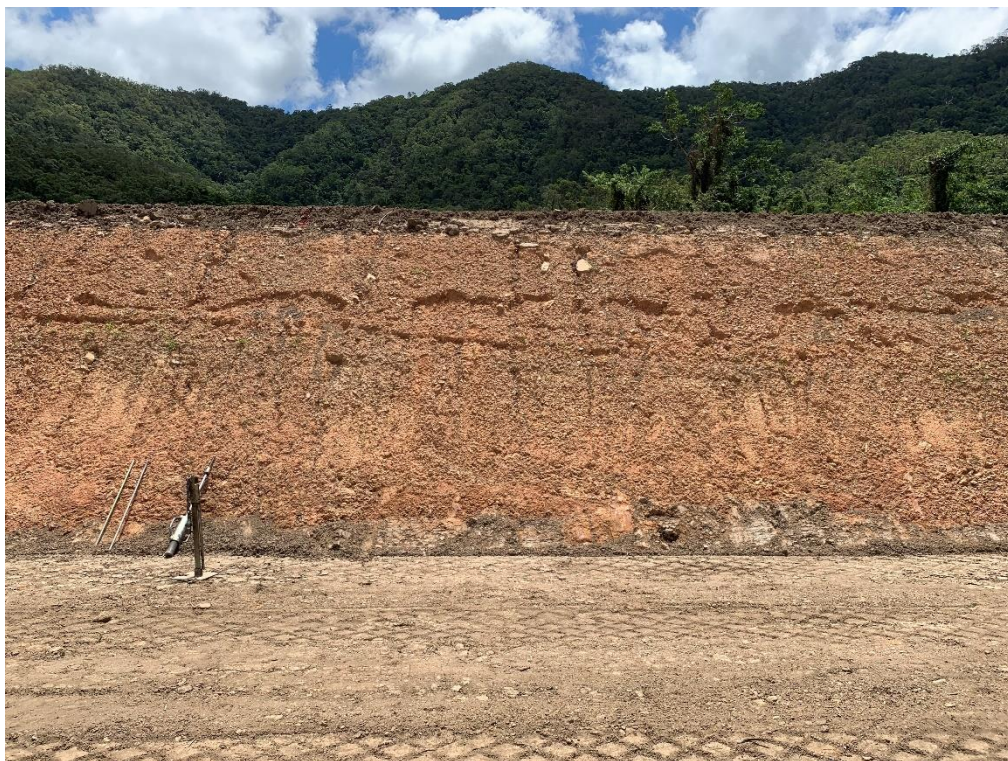
Figure 4: Batter in Lot 612 on 15 March 2021

- Lots 609 and 610:
 - Design: 1V:1H batter slope, up to 3m high; and
 - As constructed: up to 43 degrees batter slope, up to 3m high; very stiff to hard fill and residual soil.
- Lots 611 to 614:
 - Design: 1V:1H batter slope, up to 3m high; and
 - As constructed: up to 49 degrees batter slope, up to 3.2m high, very stiff to hard fill in batter and hard residual soil below batter.

- Lots 611 to 614:
 - Design: 1V:1H batter slope, up to 3m high;
 - As constructed: up to 49 degrees batter slope, up to 3.2m high.
- Lots 615, 616, 618 and 619:
 - Design: 1V:1H batter slope, up to 3m high;
 - As-constructed: up to 45 degrees batter slope, up to 3.4m high.

satisfactory FOS cannot be achieved for the current slope geometry for Lots 611 to 614 and the following measures are required:

- Lots 611 to 614 (Design: 1V:1H batter, up to 3m high): Batter to be cut to 1V:1H.

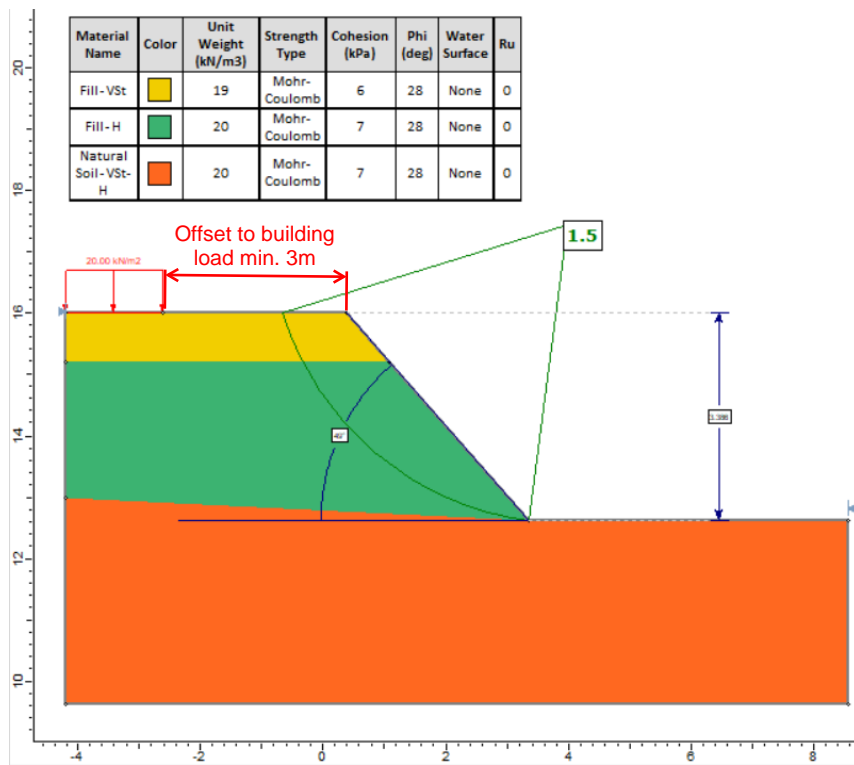
The global stability assessment of both cases is presented in Appendix C. For long term dry conditions, a factor of safety (FOS) of 1.5 is to be achieved, while for "wet conditions", i.e. short-term conditions a FOS of 1.3 is acceptable. The slope stability analysis results indicate that a

Figure C1: Lots 611 to 614 with 49 degrees batter – Dry Conditions

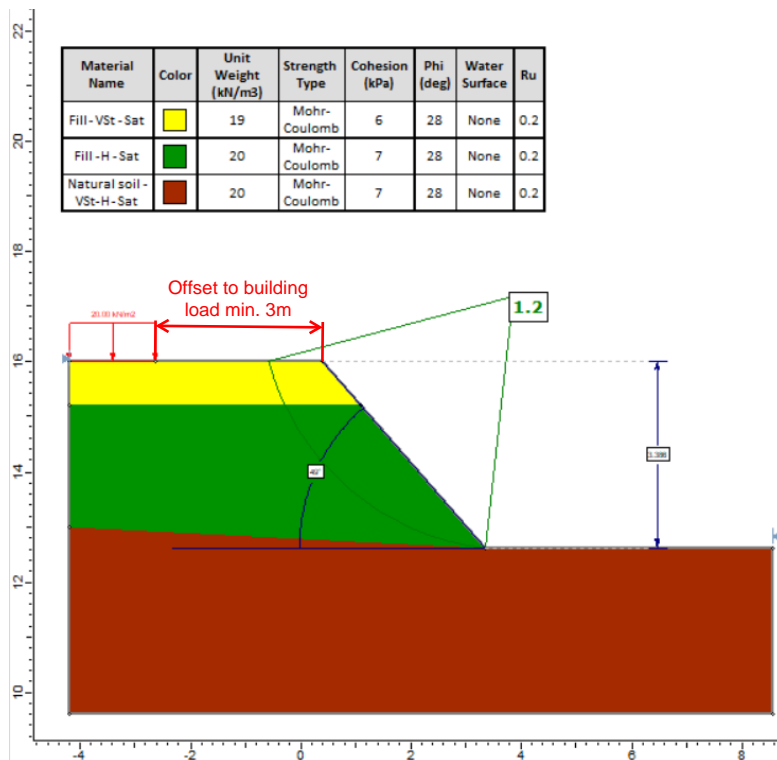
Figure C2: Lots 611 to 614 with 49 degrees batter – Wet Conditions

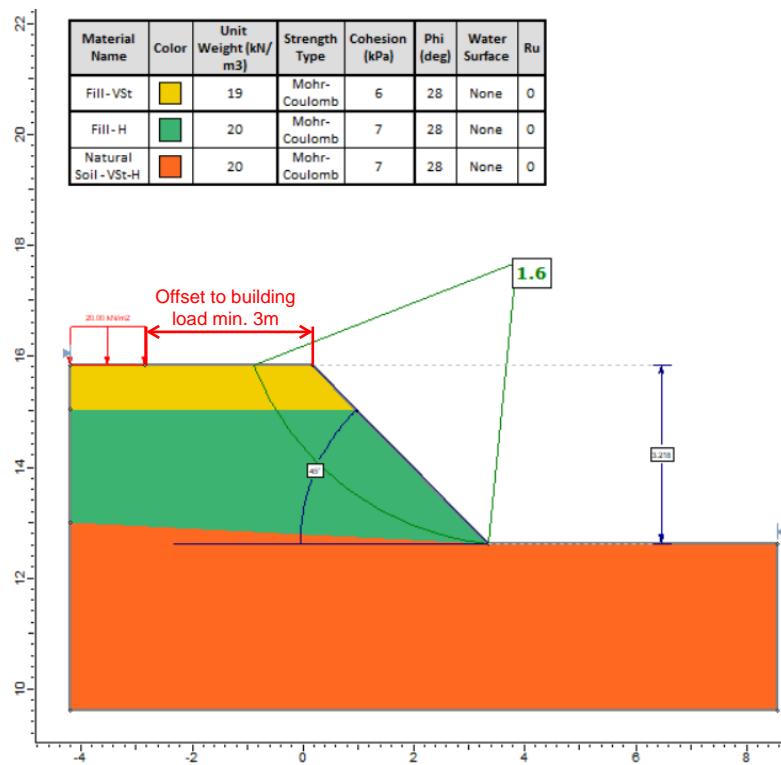
Figure C3: Lots 611 to 614 with 45 degrees batter – Dry Conditions

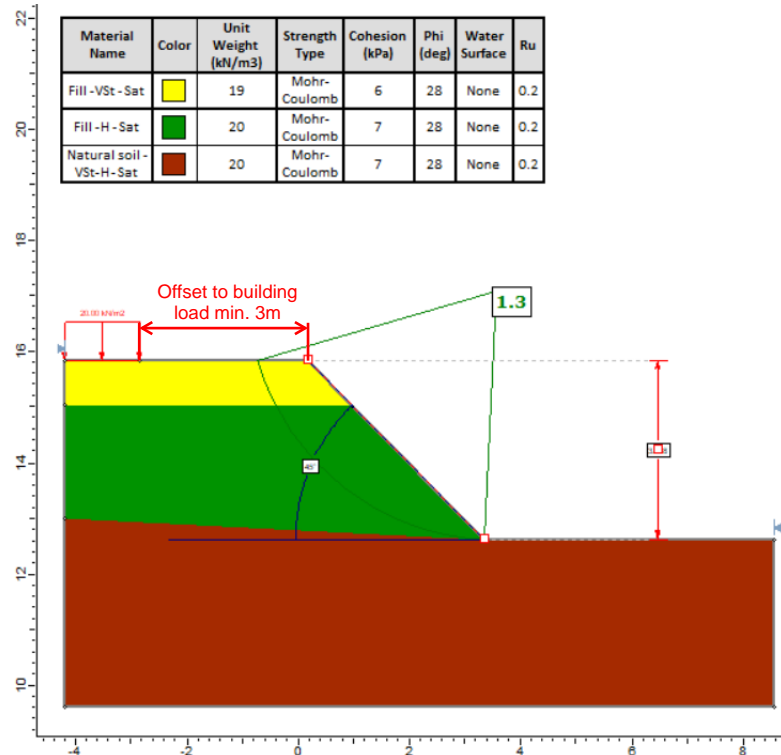
Figure C4: Lots 611 to 614 with 45 degrees batter – Wet Conditions

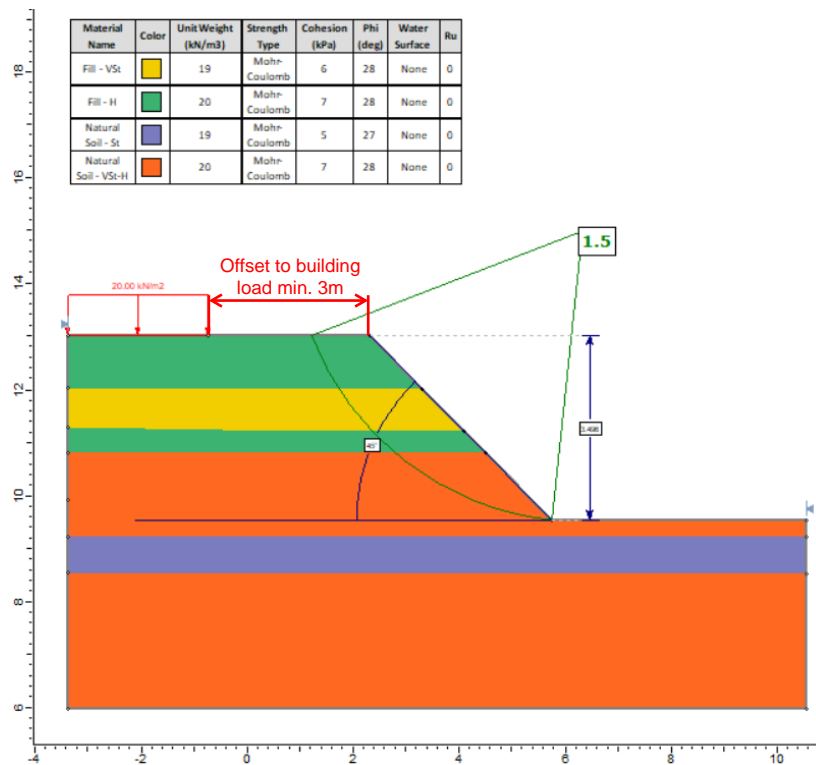
Figure C5: Lots 615, 616, 618 and 619 with 45 degrees batter – Dry Conditions

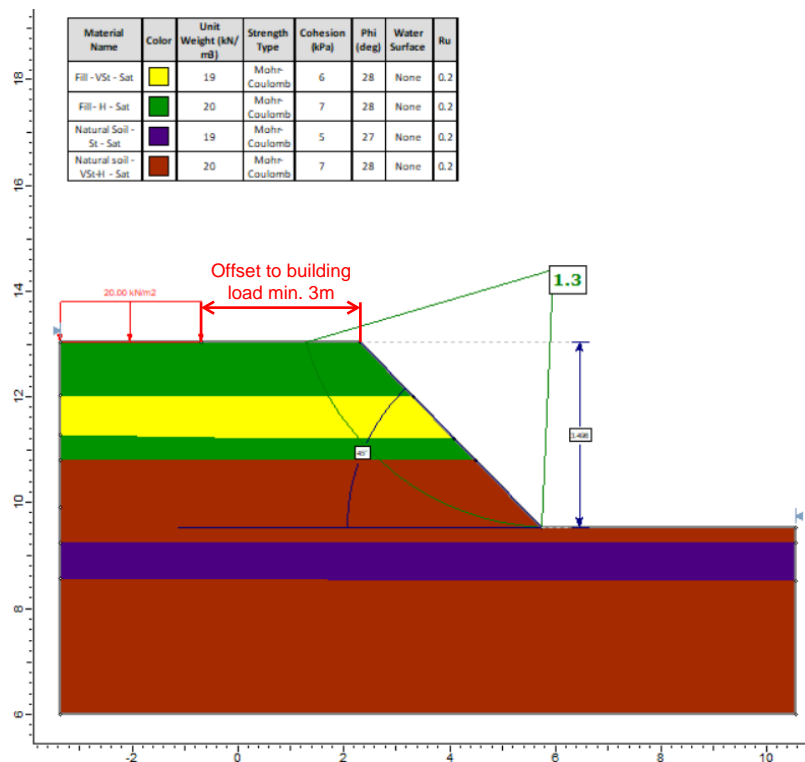
Figure C6: Lots 615, 616, 618 and 619 with 45 degrees batter – Wet Conditions
