Project Name: The Outlook Stage 6
Project Number: IH001601

Subject: Stability Assessment As-Constructed Batters

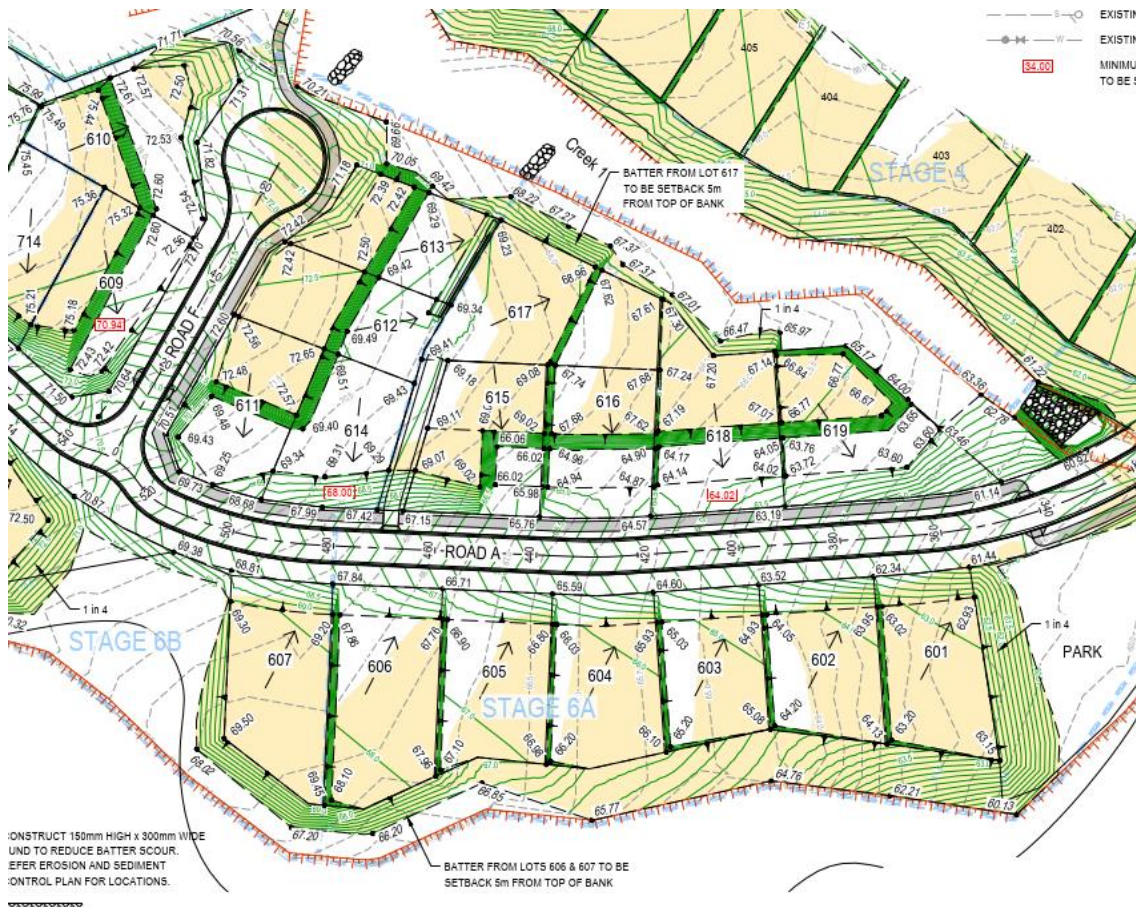
Figure 1: Batters Stage 6 The Outlook Estate

- 1V:1H batter, up to 3m high on Lots 609 and 610
- 1V:1H batter, up to 3m high on Lots 611 to 614
- 1V:1H batter, up to 3m high on Lots 615, 616, 618 and 619
